File No. 2143-43

Docket No. AC-5

REPORT OF THE CIVIL AERONAUTICS BOARD

On the Investigation of an accident,
involving aircraft of United States
registry NC 18603, in the Tagus River,
Lisbon, Portugal, on February 22, 1943.

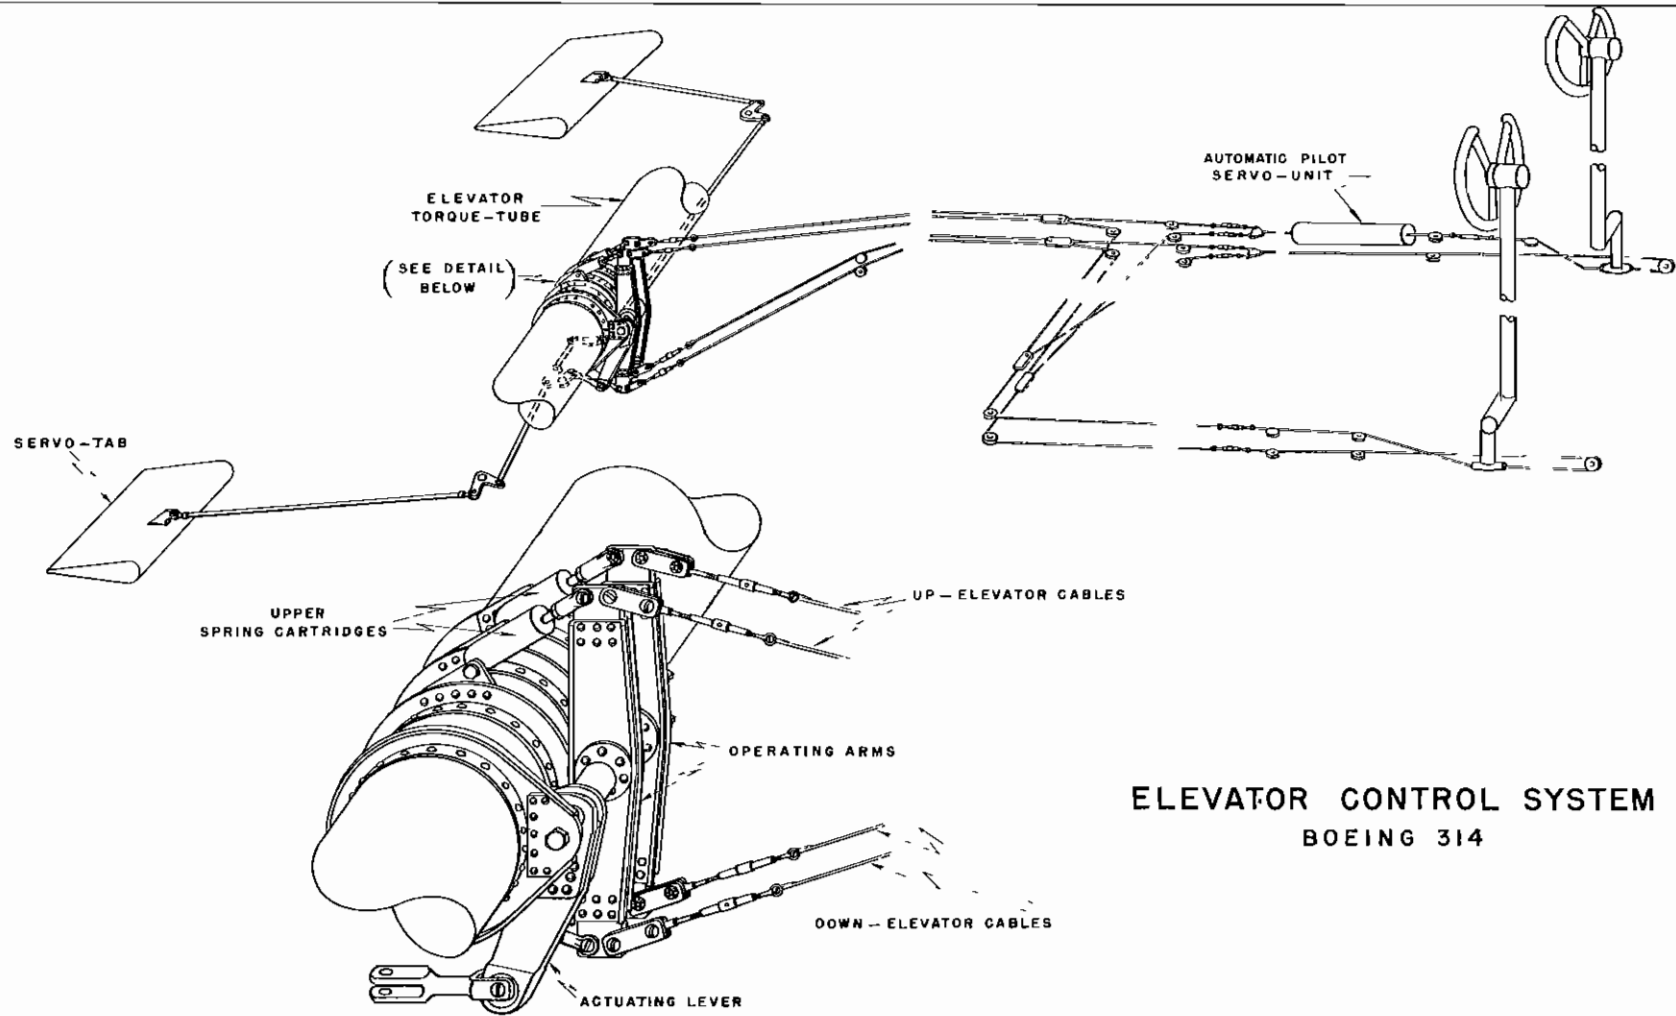
**ELEVATOR CONTROL SYSTEM
BOEING 314**

The elevator control system of the Boeing 314 consists of two sets of cables which permit operation of the elevator through an initial range of approximately 20° either side of the position of zero hinge moment by means of servo-tabs.^{4/} An additional 5° motion in either direction is attained by direct operation of the elevator through the torque-tube. The four ends of the operating arms are also connected to the torque-tube by means of four independent spring-cartridges. The purpose of these cartridges is to permit the operation of the elevators through the normal operating range by means of the servo-tabs, while still permitting direct operation of the elevators

The only individual failures in the cable control system which could render the elevators inoperative are the two cable connecting links which were recovered from the wreckage undamaged and intact.

The dual set of cables enables either the captain or first officer, or both, to operate the system in case any one cable fails. If one of the servo-tab systems should become inoperative, the other set would operate the elevators sufficiently for control. Even the failure of the hinge bolt supporting the operating arms, or the failure of the actuating lever, would not deprive the airplane completely of elevator control. The failure of one, or even all four of the cartridges would not influence the operation of the elevator through the first 20° of surface movement.

Sufficient parts of the elevator control system were recovered to permit detailed examination and study and to establish beyond reasonable doubt that the system was functioning prior to impact. The only element found to have been broken was the rod of the lower starboard spring cartridge. This break had the appearance of having occurred sometime prior to the accident. However this finding is not considered to be relevant in establishing the cause of the accident, inasmuch as even had this cartridge been broken, it would have had no effect on the operation of the airplane. Although this conclusion seemed quite apparent from a study of the design of the elevator control system, nevertheless the Board arranged with PanAm for specific tests to clarify this matter beyond a doubt. During these tests, one or more of the cartridges were disconnected and the operation of the elevator control system was found to remain normal.
